NATIONAL ADVISORY COMMITTEE FOR AERONAUTICS

A POSITIVE-REPLICA TECHNIQUE FOR EXAMINING FINISHED METAL  
SURFACES AND ITS APPLICATION TO AIRCRAFT-ENGINE CYLINDERS

By Thomas P. Clark

Aircraft Engine Research Laboratory  
Cleveland, Ohio

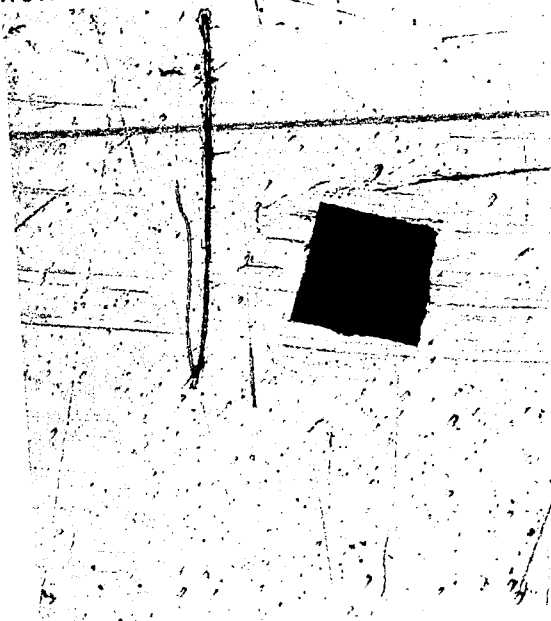
(a) Photomicrograph of surface.

Figure 1. - A metallographically polished steel surface with a roughness of 1.5 microinches, rms. X100.

Figure 1(a) is a photomicrograph of a metallographically polished steel surface; figure 1(b) is a photomicrograph of its

positive replica. Figures 2(a) and 2(b) present a similar treatment of a lapped steel surface. The square holes that are visible in the photomicrographs were made with a Rockwell hardness tester. These figures show the degree of fidelity of reproduction possible with the positive replica. The specimen shown in figure 1(a) had a roughness of 1.5 microinches, rms, as determined by the Brush surface analyzer. Figure 1(b) illustrates the resolution possible with the positive replica at the small roughness value of 1.5 microinches, rms.

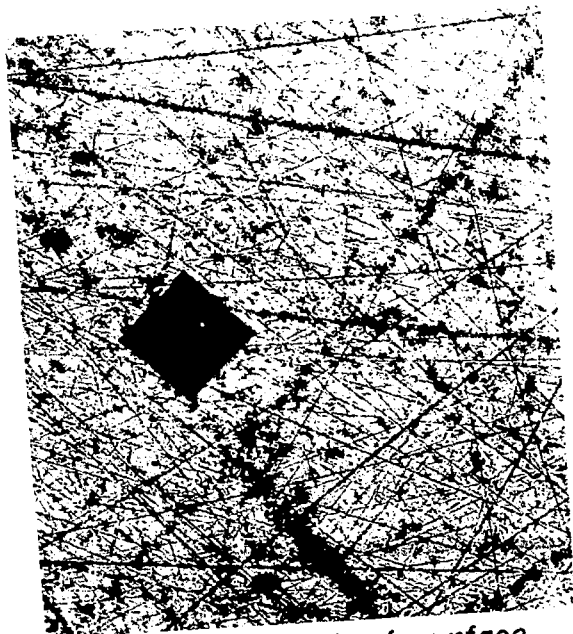
(a) Photomicrograph of surface.

Figure 2. - A lapped steel surface with a roughness of 8.0 microinches, rms. X100.

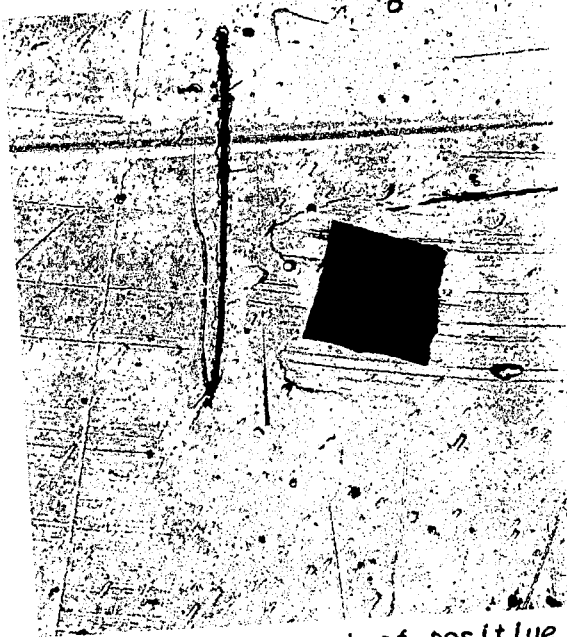
(b) Photomicrograph of positive replica of surface.

Figure 1. - A metallographically polished steel surface with a roughness of 1.5 microinches, rms. X100.

The higher reflectivity of a silver surface as compared with a steel surface must be considered in interpreting surface character. The fine structural detail is sometimes less evident than it is in the original specimen because of the increased specular illumination of the pits and grooves of the replica. Although the fine detail shown in figure 2(a) is also shown in figure 2(b), figure 2(b) shows much less contrast. In making of photomicrographs of positive replicas, only two-thirds the exposure given to the original steel surface is necessary.

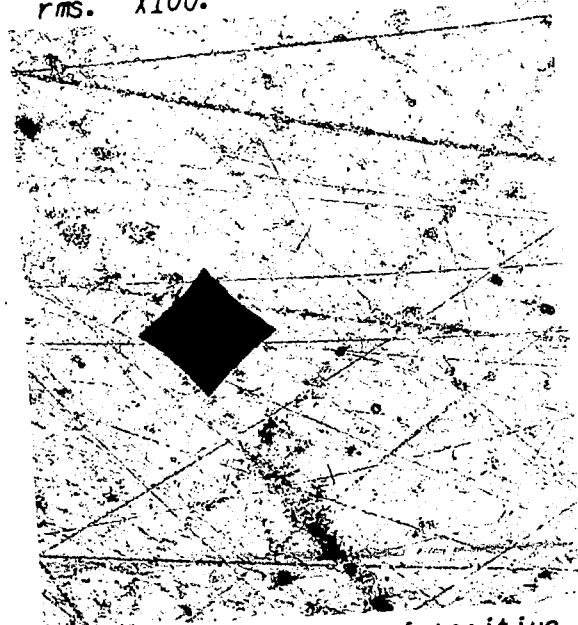
(b) Photomicrograph of positive replica of surface.

Figure 2. - A lapped steel surface with a roughness of 8.0 microinches, rms. X100.

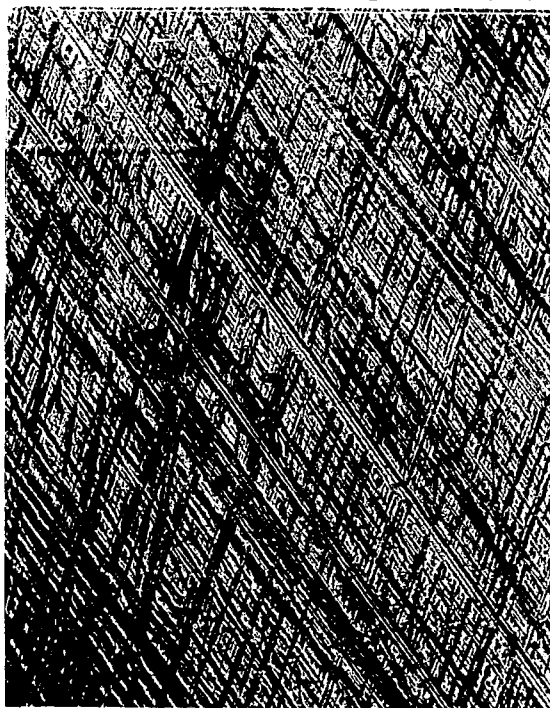
Figure 4. - A positive replica of a finely honed Allison V-1710 cylinder barrel. X112.

barrel is shown in figure 3. Figure 4 shows the comparatively finely honed finish given to the Allison cylinder barrel at AERL in the course of a general engine overhaul. The surface of the coarsely honed new cylinder after 48 hours of test running is shown in figure 5 and the surface of the finely honed cylinder barrel after 35 hours of test running is shown in figure 6. Figure 7 shows the surface of the coarsely honed cylinder after 100 hours of test operation. All these photomicrographs were taken along the middle portion of the major-thrust face of the barrel and represent the general surface appearance of the cylinder barrel.

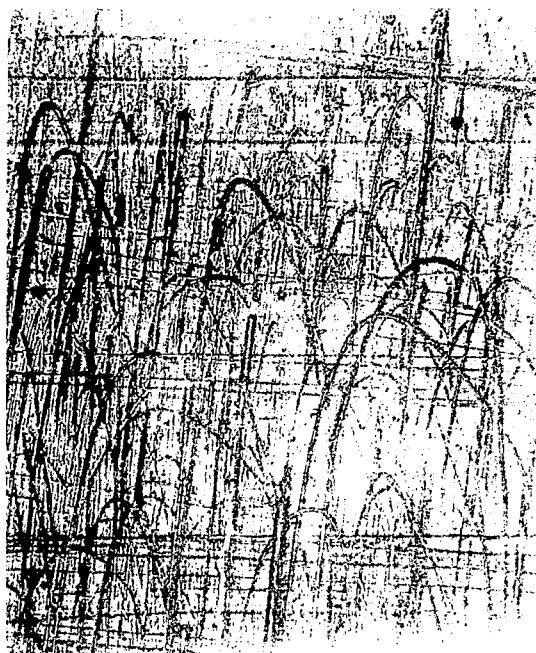
Figure 8. - A positive replica of the area at the top of ring travel in an Allison V-1710 cylinder barrel after 120 hours of test running. The top ring was free. X112.

had been run 33 hours, one 120 hours, and the other 225 hours on a test stand. These photomicrographs are shown in figures 8 to 14. The fact that the cylinders examined in this replica study were used for ring-sticking tests must be kept in mind in interpreting the figures. In the cylinders that had been run for 33 and 225 hours, the top ring was stuck in the ring groove causing a different pattern on the cylinder wall at the top of ring travel from that which is found at the same position in the barrel that had been run for 120 hours where all the rings were free.

Figure 8 shows the area within the top ring band in the cylinder in which the top ring did not stick. The looping scratches were presumably generated by the top compression ring as it rotated slightly at the top of the stroke. Figure 9 shows the area at the top of ring travel in the barrel run for 33 hours in which the top ring was stuck. The burnishing effect of the ring impact has removed the scratches in this barrel but has left the deeper cross-hatched grooves of the honing operation. Figure 10 shows a replica of the worn surface of the barrel run for 225 hours taken at approximately the same area shown in figure 9. The ring was stuck in this cylinder. This cylinder presents an excellent example of the surface found at the top of ring travel in a worn cylinder barrel. A characteristic burnished area with the fringe of smeared metal extending downward is clearly shown.

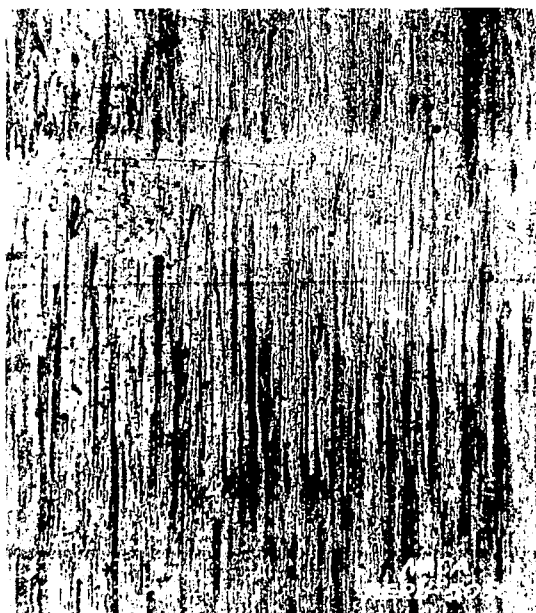
Figure 10. - A positive replica of the area at the top of ring travel in an Allison V-1710 cylinder barrel after 225 hours of test running. The top ring was stuck. X112.

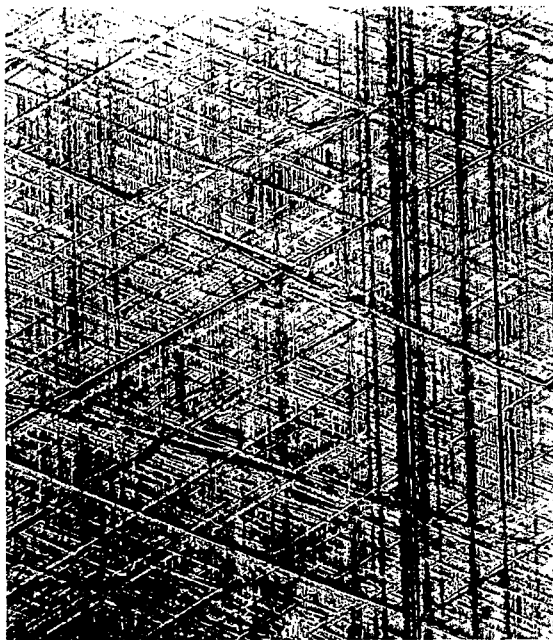
Figure 13. - A positive replica of the area at the bottom of ring travel of the top ring in an Allison V-1710 cylinder after 33 hours of test running. X112.

Figure 13 is a replica of the area containing the ring band at the bottom of ring travel in the barrel slightly worn after 33 hours. The ring bands have not yet begun to appear in this area. Figure 14 shows the top ring band at the bottom of ring travel in the worn barrel after 225 hours. In this area, the burnishing effect is not so noticeable as it is at the top of ring travel, but the fringe of smear metal is quite evident. At the top of ring travel the smear points downward whereas, at the bottom of ring travel the smear points upward. The edges of the smears shown in figures 10 and 14 start, in each case, at the forward edge of the ring as it leaves either the top or the bottom position of ring travel.

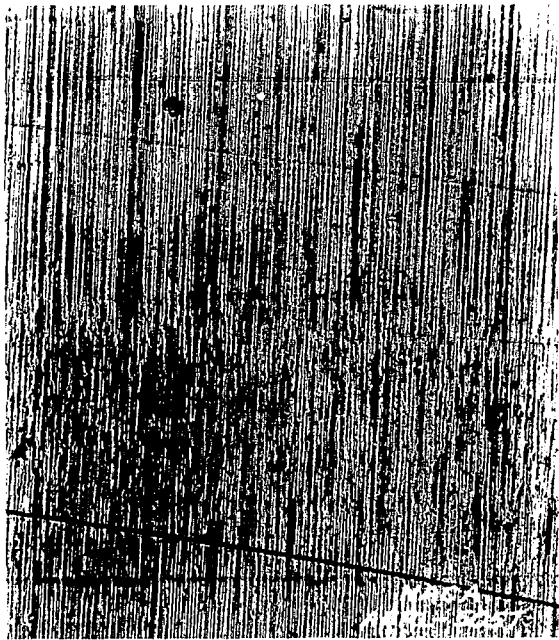
Figure 14. - A positive replica of the area at the bottom of ring travel of the top ring in an Allison V-1710 cylinder after 225 hours of test running. X112.
